Date: November 21, 2010  
To: Water Solutions Engineering Customer  
Subject: Boiler Inspection on November 17, 2010

## **Background**

Two (2) gas fired boilers are used to produce steam. The older boiler is a water tube type capable of producing approximately 35,000 lbs. of steam per hour and is typically only used for back up situations. The new boiler which was installed in 2008 is a fire tube capable of producing 23,500 lbs. of steam per hour and is the primary boiler for the plant. Until August 2010, the boiler chemicals used to treat this boiler was EDTA, Sulfite, and Amine. During the July 2010 boiler inspection of the new boiler, large amounts of iron scale were discovered inside the bottom of this boiler which was of great concern. In August of 2010, the treatment program was changed to a polymer/phosphate blend, liquid sulfite, and amine. The previous EDTA treatment program was premixed with softened water and fed to the feed tank; however, the new chemical program was recently changed to direct feed of the three chemicals using independent chemical pumps. A boiler blowdown controller has also been installed but is not operational at this time. Two very critical items s

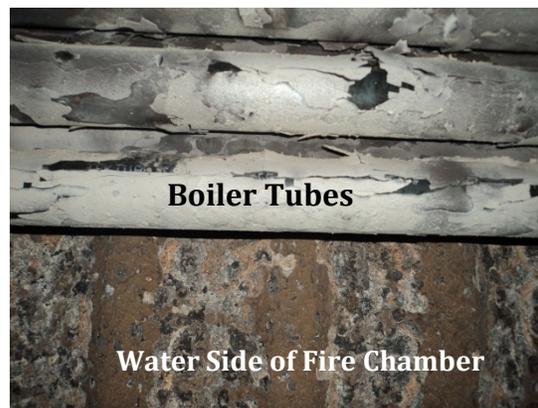
### **Front Left Port—Boiler Tubes and Water Side of Fire Chamber**

Pictures were taken through the left front port (see below). As you can see, the tubes have a very thin and flaky scale covering approximately 75% of the water side. Since we do not have pictures from the July 2010 inspection for comparison, we are assuming this is the result of the entire chemical treatment drum (polymer/phosphate) being fed just a week prior to this inspection. If that is the case, this scale will be primarily phosphate scale. However, if the tubes showed significant scale buildup in the July 2010, this could be the result of the softening and removing the previously deposited scale. Lab results from the scale analysis should provide some clarification. The water side of the fire chamber shows evidence of pitting most likely caused by the EDTA treatment program.

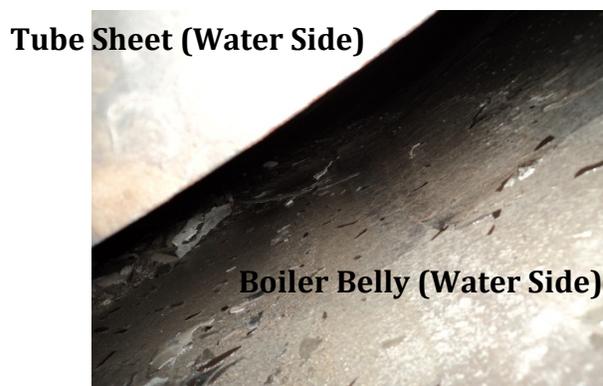
### **Rear Port—Bottom Section of Tube Sheet (Water Side) and Belly**

Pictures were taken through the rear port (see below) and, as you can see, the flakes which can be seen on the tubes are also present on the belly of the boiler. It is recommended but not necessary that these flakes be removed from the boiler before start-up. Again, scale analysis will provide more answers to the origin of this scale. However, it is not iron scale which was present during the July 2010 inspection.

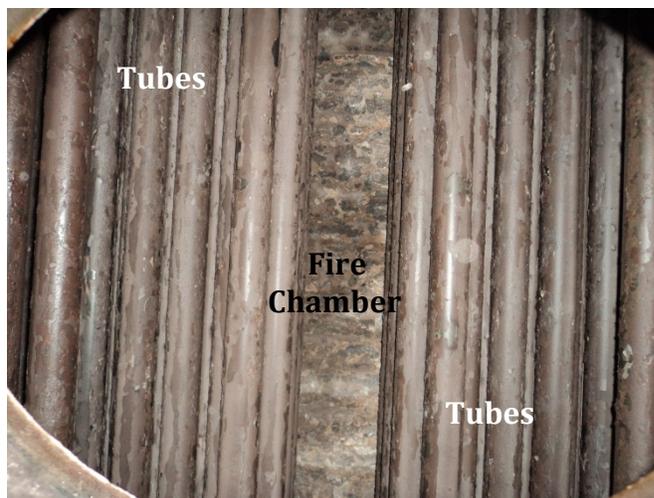
### **Top Port---Top Section of Tubes**

Pictures were taken through the top port (water side) and you can see the same thin, soft and flaky scale on this section of tubes as well. It is a little more difficult to see as the section was still wet as the port was opened just prior to taking these pictures and moisture was present. We do try to achieve a very thin and non flaky coating on the water side of the tubes to prevent corrosion; however, the coating present during this inspection was too thick and too flaky. Again, the lab analysis of the scale will provide more insight.

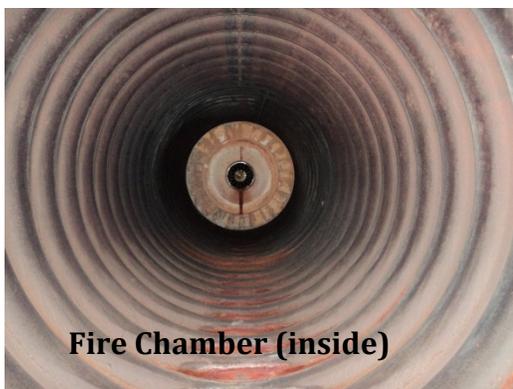
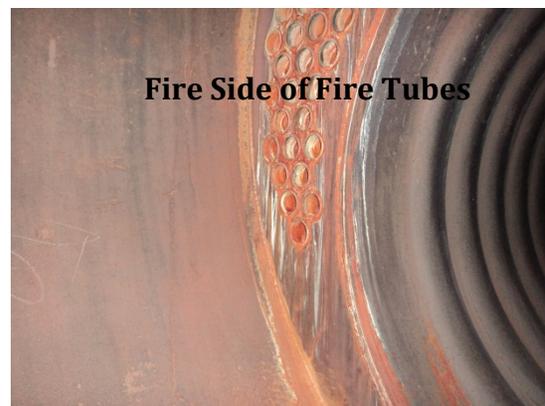
### **Fire Side of the Fire Tubes and the Open End of the Fire Section**

The fire section of the boiler was inspected and there were not any evidence of fire side or fuel deposits.
