Date: May 4, 2010
To: Water Solutions Engineering Customer
Subject: Boiler Inspection on April 29, 2010

Water Solutions Engineering

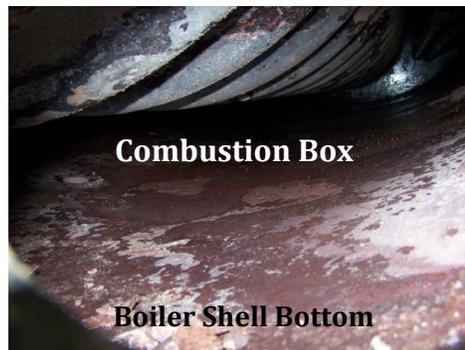
Front Port—Boiler Shell Bottom

Pictures were taken through the front port (see below) and, as you can see, the boiler has some scale but very minimal.

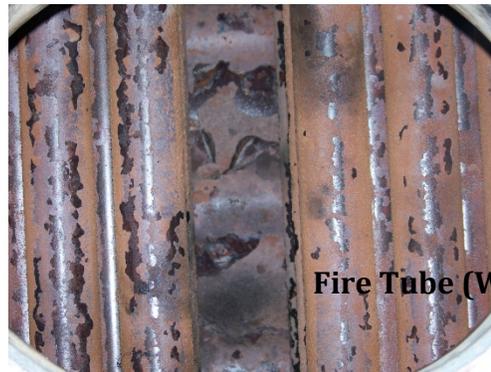
Fire Tube (Water Side)

Pictures were taken through the top port (see below) and, as you can see, the fire tubes have some scale on the water side but minimal amounts. Some iron flaking of the pipes is evident but nothing to be concerned about at this time.

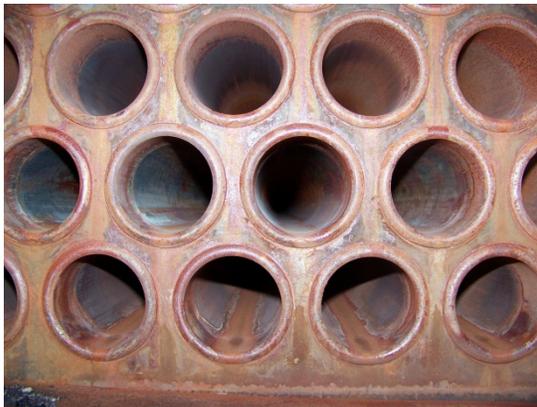
Fire Side of Fire Tubes

The fire section of the boiler was inspected and there were not any evidence of fire side or fuel deposits. JCI was working to repair the insulation and insulation sheft that was damaged. Pictures are below.
