Date: July 15, 2009
To: Water Solutions Engineering Customer
Subject: Fulton Boilers Inspections on July 14, 2009

Water Solutions Engineering

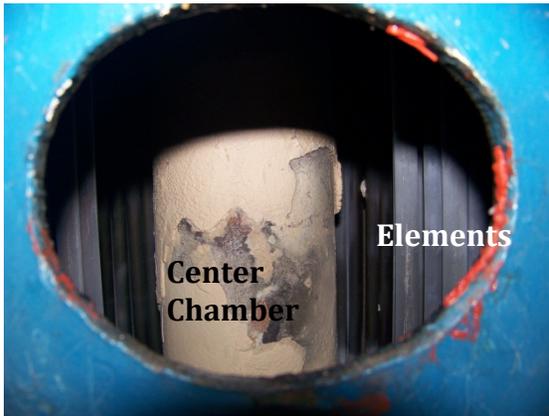
This boiler contained the greater amounts of scale which appeared to be calcium carbonate. The bottom of this boiler contained scale in excess of 1/2" in thickness around the shell and center chamber. The surfaces of the electric heating elements showed little to no scale buildup on the top and bottom portions. The pictures below are from the Boiler #1 inspection.

Boiler #1: Top Handhole

3. Install Stenner Pump Control Module (PCM) to interface between water meter and Stenner pump for precise chemical injection----**Complete**
4. Physically remove as much scale as possible from each boiler prior to putting back in service.

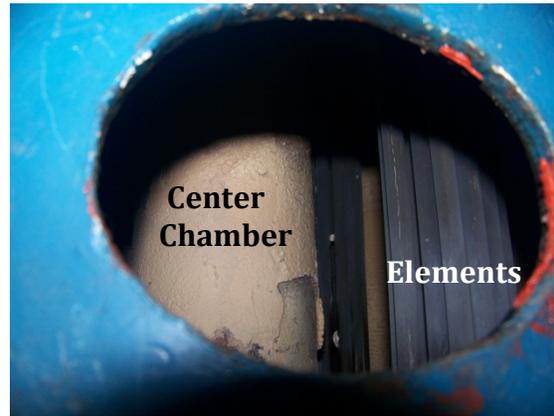
Boiler #1: Top Handhole

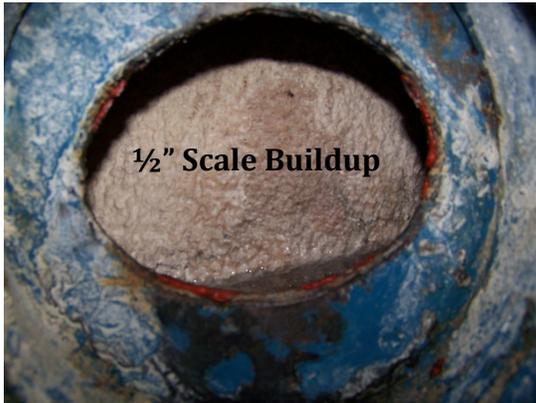
**Boiler #1: Bottom Hand Hole
before Scale Removal**

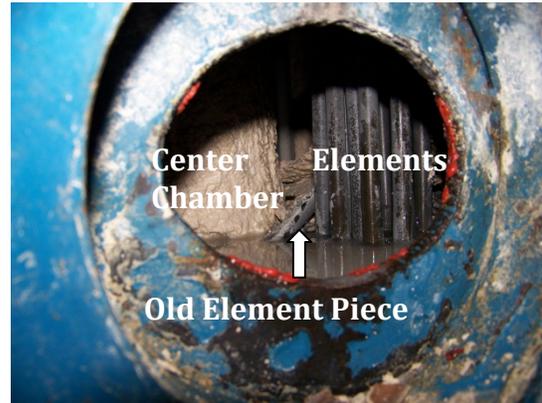
**Boiler #1: Bottom Hand Hole
after Scale Removal**

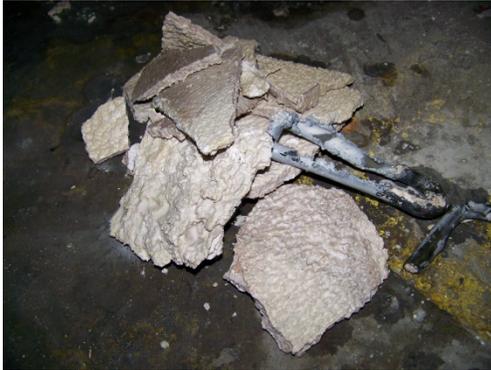
Boiler #1: Scale from Bottom Hand Hole

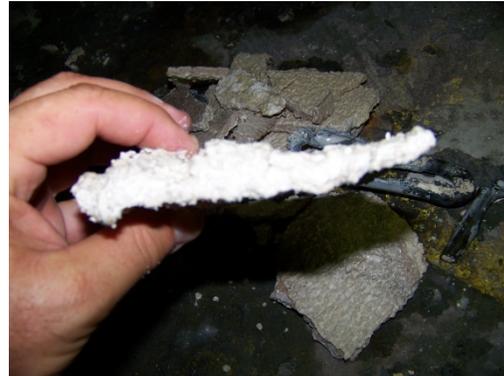
Boiler #1: 1/2" Thick Scale from Bottom Hand Hole

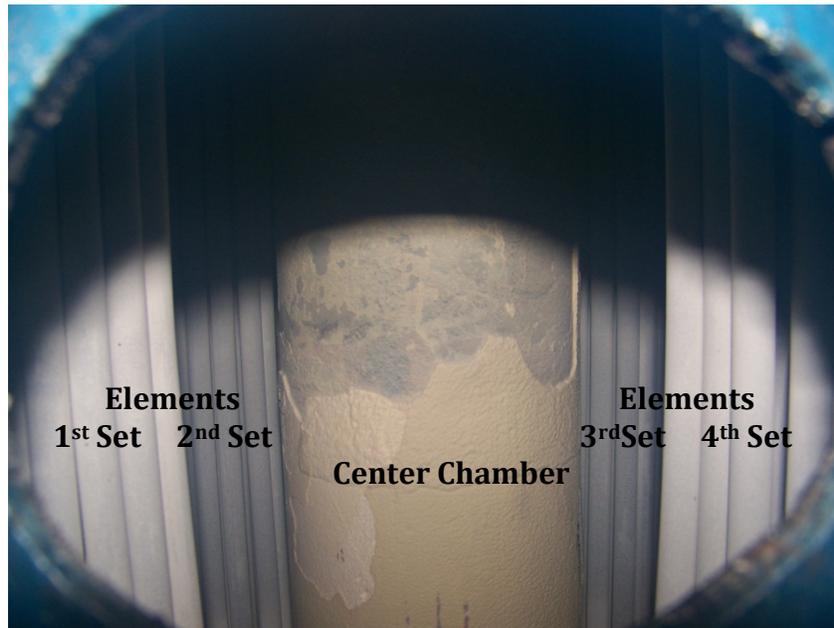
This boiler did not contain as much scales as Boiler #1; however, the scale on the shell and center chamber is significant. Also, this boiler had more scale build up on the electric element rods. The shell and center chamber had scale thickness between 1/16" thick at the top and 1/2" at the bottom in some areas. The scale on the elements appeared to be very little at the top but approximately 1/16" thick in some areas on the bottom section. The pictures below are from the Boiler #2 inspection.

Boiler #2: Top Hand Hole

Scale layer can be seen on the center chamber and the four (4) elements are shown with the white scale layer more noticeable on the forward most sets (1st and 4th).

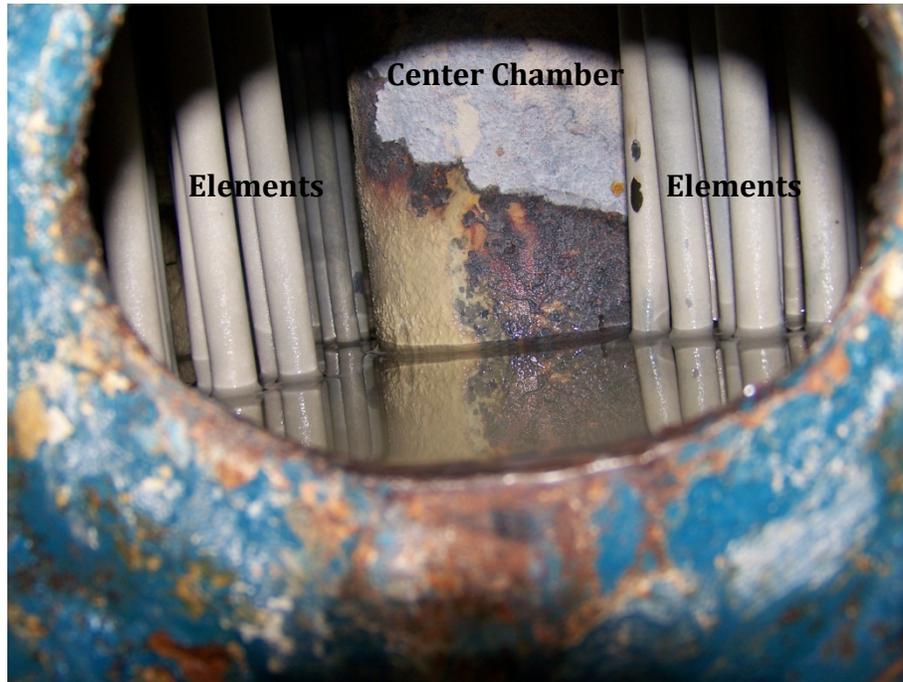
Boiler #2: Bottom Hand Hole

From the picture above, increase scale buildup can be seen on the elements in the bottom section of Boiler #2. Also, scale and corrosion is noticeable on the center chamber.
