## COUPON ANALYSIS REPORT

For: **Water Solutions Engineering Customer**

Date: 2/04/2011

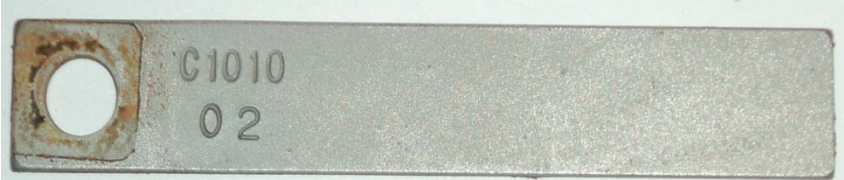
This corrosion coupon report is for the mild steel and copper coupons removed from the tower coupon rack on 11/16/2010. The corrosion rates for Mild Steel were excellent at 0.15 MPY and are lower than the last reading of 0.87 MPY. The copper was also very good at 0.16 MPY and is down from the last reading of 0.27 MPY. The industry specification for copper is less than 0.3 MPY and 3.0 MPY or less for mild steel. Typically, the industry standard is to allow the coupons to be exposed for approximately 90 days and these were exposed for 89 days.

<b>Specimen No.:</b> 02	<b>Date Installed:</b> 8/19/2010
<b>Coupon Type:</b> ½ inch C1010 Mild Steel	<b>Date Removed:</b> 11/16/2010
<b>System ID:</b> South Tower	<b>Exposure:</b> 89 Days
<b>Sampling Point:</b> Coupon Rack	<b>Corrosion Rate:</b> 0.15 MPY
